Flip Chip Packaging of a MEMS Neuro-Prosthetic System

L. Del Castillo, R. Graber, S. D'Agostino, M. Mojarradi and A. Mottiwala
Jet Propulsion Laboratory, California Institute of Technology
4800 Oak Grove Drive
Pasadena, California 91109
(818) 393-0418, (818) 393-5055, Linda.DelCastillo@jpl.nasa.gov

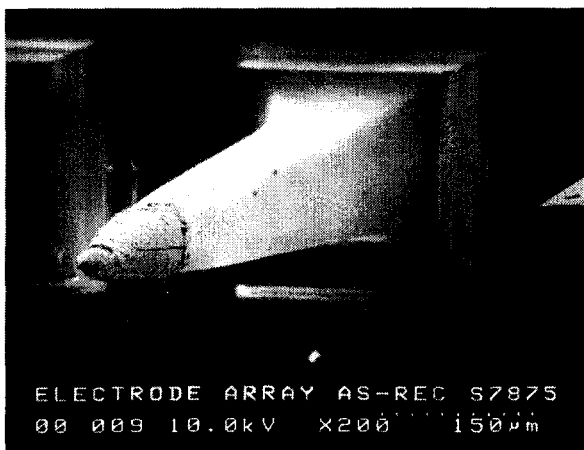
Figure 2. An SEM micrograph of a single electrode is shown. The electrode is made of Si, jacketed in SiN, with PtSi/TiW/Pt at the tip.

located outside the body. The electrode array, which is capable of extracting signals from the brain, consists of a 10 x 10 array of fine 1 mm long, electrically isolated Si electrodes (Figure 2). The electronic chip attached to the array will be capable of providing on chip conditioning/processing of the extracted data, while simultaneously measuring the temperature of the surrounding tissue.

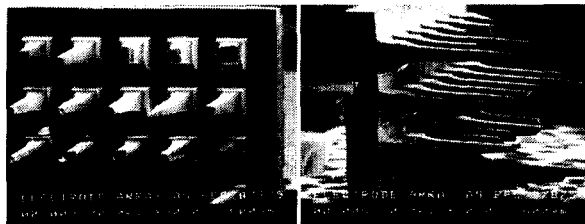
Figure 4. Early holding fixture designs were not successful in protecting the arrays. Above are two SEM micrographs of electrode arrays fractured during processing.

The delicate nature of the Si electrodes (Figure 4) complicated the design of the holding fixture. Fragile ledges inhibited the use of mechanical fixtures and processing temperatures reduced the number of viable adhesives. Finally, a fixture was designed to protect the electrodes within a well that was slightly deeper than the 1.5mm long scrap arrays. A "shelf" along the edges of the well protected the ledges and ensured a relatively even bonding surface.
